FIELD REPORT

Report No.	2	Date of Report	June 29, 2022
Project	284-286 20th Street	Date of Visit	June 8, 2022
Project Address	284-286 20th Street Brooklyn, NY 11215	Time of Visit	9:30 AM - 10:45 AM
Project Scope	Façade Repair Program		
Prepared for	Nicholas Murphy – Goldin Choice Management		
Copy	Distribute as required.		
Prepared by	Amir Chouhan	Weather	Sunny
Checked by	Walter Martinez	Temp. Range	65-70 degrees F.

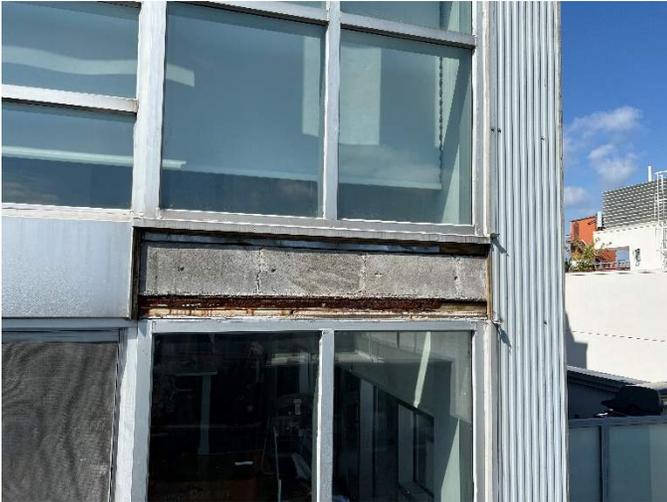
IMAGE 1.1: PROBE #1 – GENERAL VIEW

Probe #1: Corrugated metal panels at the spandrel area were removed at the top floor of 284 20th Street, North elevation. CBR advised that no fasteners were anchoring the actual panel but that L-channels or J-channels fastened at the top and bottom were the only pieces holding the panel in place. This condition is potentially hazardous to pedestrians and must be addressed immediately. The probe revealed that the waterproofing is missing behind the corrugated metal panel. This may explain why leaks have been associated with this particular location. As a result of the missing waterproofing, the internal structural steel supporting the façade was heavily delaminated and corroded. Pieces of the steel could easily be removed by hand. This is a direct result of exposure to moisture which caused it to rust and over time it corroded the steel. The level of corrosion observed may also be contributing to a hazardous condition. It was also revealed that the windows were missing primary sealant at the head & sill. Instead, the construction relies on the caulk joints of the metal spandrel panels as a primary means of protection. This also may explain why leaks have been associated with this particular location.

Information or Action Required: Missing window sealant and waterproofing must be installed in order to protect the building construction. Structural Engineer to review condition of existing corroded steel at façade and advise on remedial action. Structural Engineer to review railing anchorage to verify code compliance.

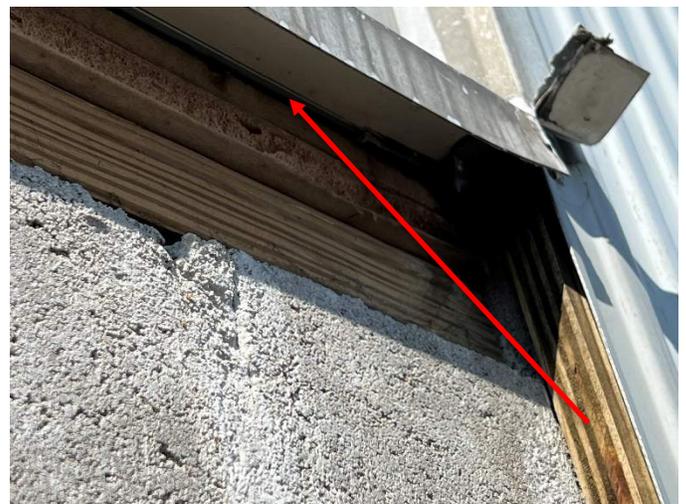
IMAGE 1.4: MISSING WINDOW SEALANT

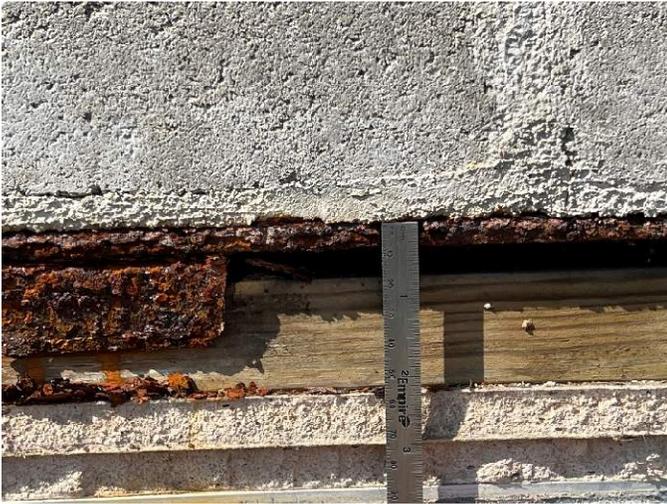
IMAGE 1.5: CORRODED STEEL

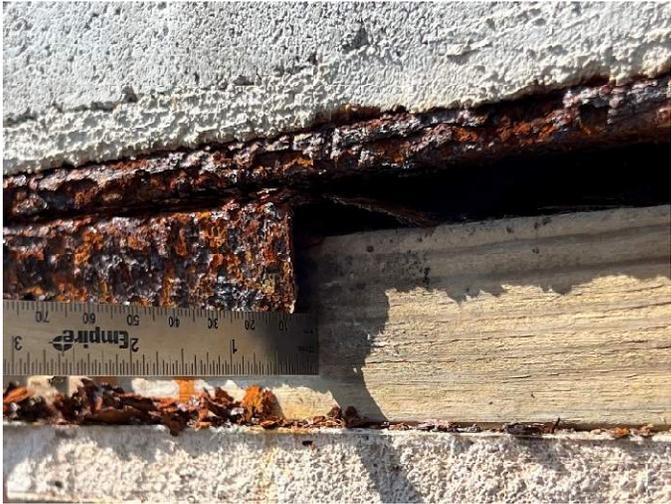
IMAGE 1.6: CORRODED STEEL

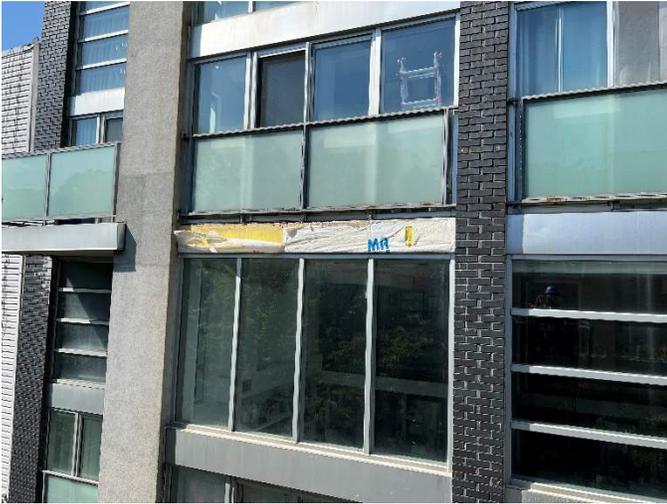
IMAGE 1.7: PROBE #2 OVERVIEW

Probe #2: Metal panel spandrel panels were removed at the 2nd floor slab on the North elevation on 286 20th Street. CBR advised that no fasteners were anchoring the actual panel and that only caulking was holding the panel in place. This condition is potentially hazardous to pedestrians and must be addressed immediately. Probe #2 revealed the use of what appeared to be an air barrier. It was also observed that the brick masonry did not include any waterproofing end dams or any provisions for draining rain water. Railing fastener penetrations into the adjacent construction were unsealed. Some railing fasteners were not anchored into structure. Similar to probe #1, these conditions are likely the cause of the water leakage conditions observed on the interior and must be addressed immediately.

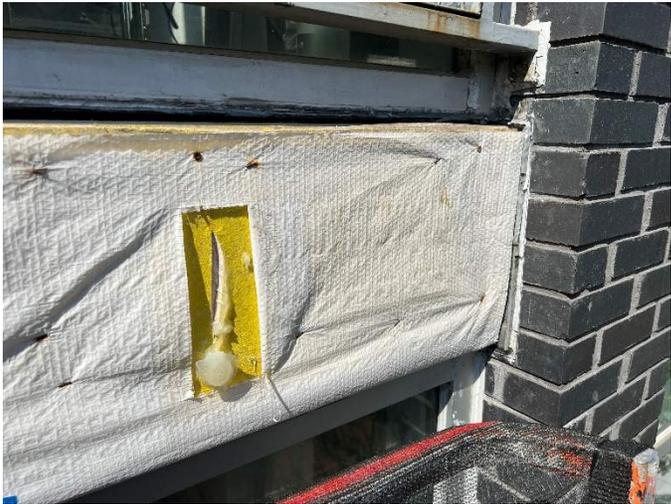
IMAGE 1.8: PROBE 2 – AIR BARRIER WITH CUT OUTS

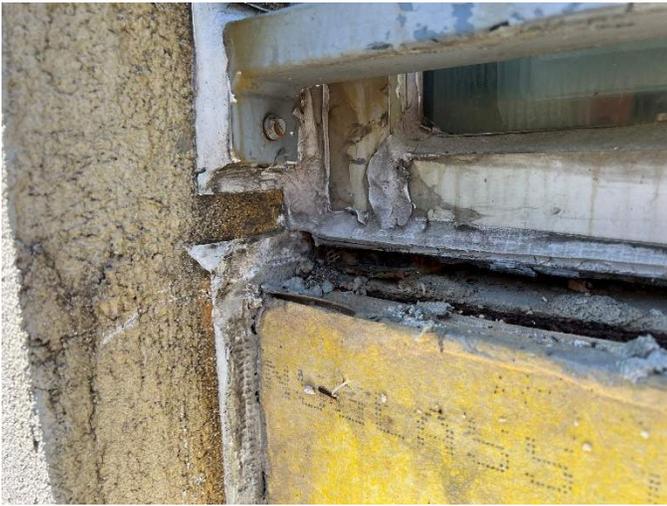
IMAGE 1.11: PROBE 2 – MISSING WINDOW SEALANT

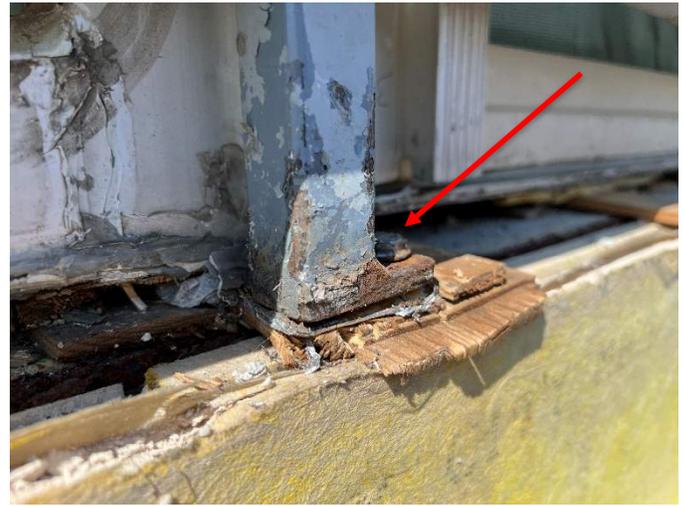
IMAGE 1.12: RAILINGS ANCHORED TO SHEATHING

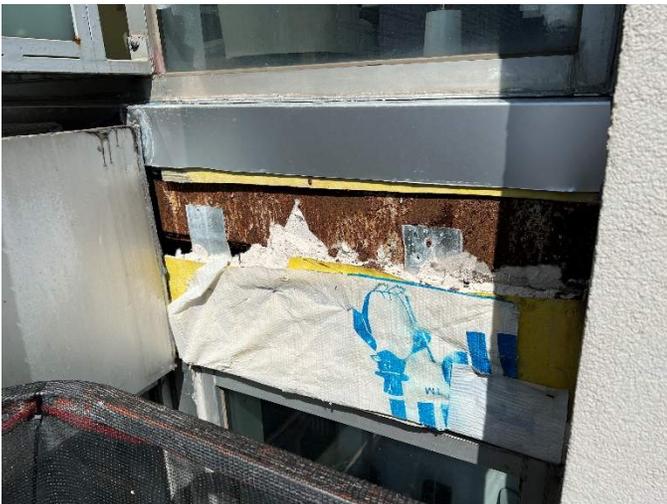
IMAGE 1.14: PROBE #4 OVERVIEW

Probe #4: This location was similar to probe #2; however, the structural steel was visibly corroded similar to probe #1. The exterior sheathing was observed to be anchored to thin pieces of thin gauge metal straps rather than to structural metal studs. This condition and the poor construction practices observed are potentially hazardous to pedestrians and must be addressed immediately. See description of probe #1 above.

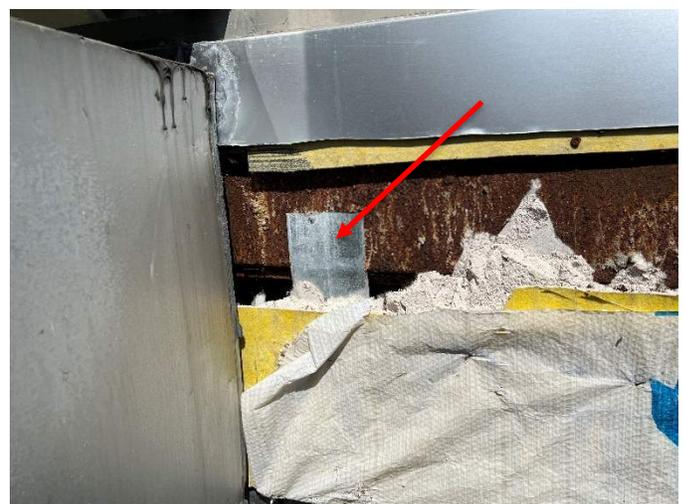
IMAGE 1.15: METAL STRAPS USED TO ANCHOR SHEATHING

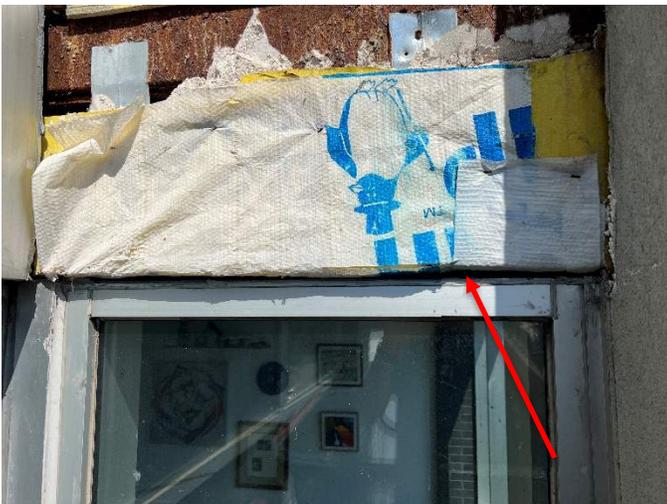
IMAGE 1.16: MISSING WINDOW SEALANT

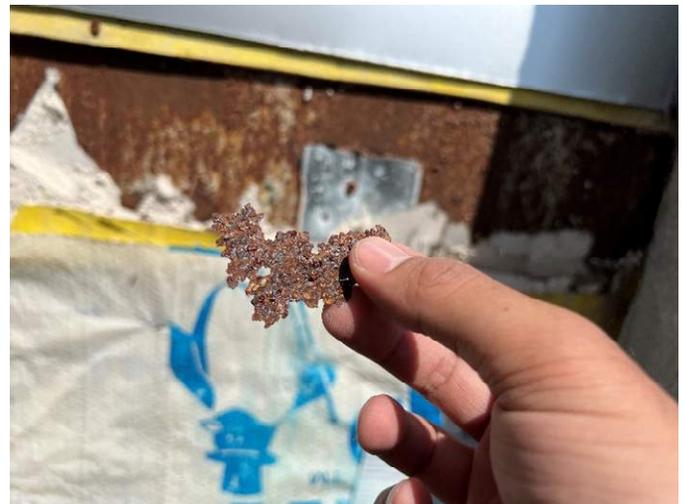
IMAGE 1.17: DELAMINATING STEEL @ PROBE #4
